Water Repellents and Anti-graffiti : a Standard Safe Approach ?

Y. Vanhellemont¹, H. De Clercq² and M. Van Bos²

Abstract

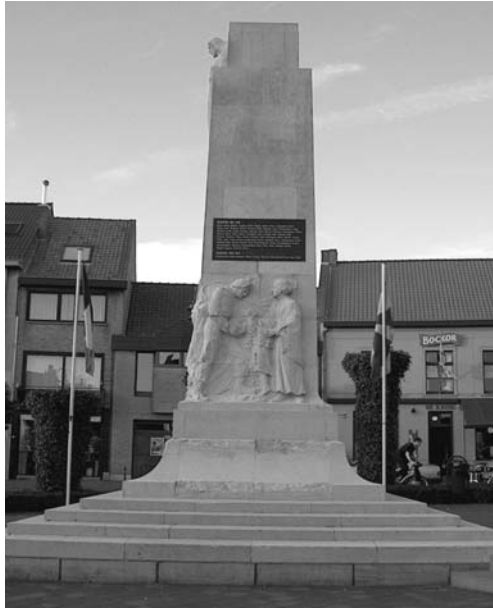
Figure 1: War monument at Lichtervelde

Built in the shadow of the church, the War monument at Lichtervelde (Figure 1) was constructed to remember the victims of the second World War in 1946. The type of material of this pyramidal construction is described in the archives as the French Massangis limestone “Roche Claire”. At the end of the 1990’s the local community decided to apply a water repellent and an anti-graffiti product. The water repellent product was applied to the entire monument, while the anti-graffiti product was applied only to the base of the monument, including the sculptured parts.

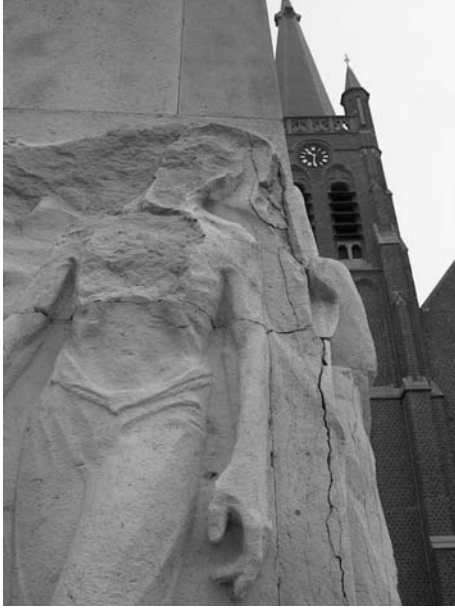
Soon after the intervention, cracks developed and severe material loss occurred in some blocks of the lower part of the monument while others remained undamaged (Figure 2). Despite the almost complete removal of the anti-graffiti product one year later, the deterioration continued.

Figure 2 : Crack formation and material loss

Based on this investigation, it could be concluded that a durable conservation and restoration plan is hardly possible. Damage is irreversible and cannot be undone. To begin with, there was the poor selection of a frost sensitive limestone for the panels of the monument at

the time it was erected. Then came the application of a water repellent and an anti-graffiti product. If, as is likely, deterioration had already begun, the application of the anti-graffiti product accelerated the deterioration. Especially the anti-graffiti product, being a combined formulation of a polyacrylic and polyurethane, is characterized by a low water vapour permeability. Hence, any water penetrating into the monument is trapped inside. Because water can still penetrate through the flat, unprotected top of the monument, or as rising damp, and certainly through damaged stones or joints. The trapped humidity results in crack formation and material loss during the freeze-thaw cycling in winter months.

Even a careful removal of the anti-graffiti product will not help. Because all the cracks and fissures that have formed have weakened the stone so that damage will proceed at a much faster rate than before.

- Covering, eg by means of lead sheeting, of the horizontal part on the top of the monument. Because the application of a water repellent product on such surfaces to prevent water infiltration, is insufficient. An appropriate water run-off system (such as a narrow metal profile that takes the role of a dripstone) should have been included.
- Reduction or complete elimination of rising damp at the lower part of the monument. Due to its massive construction, and the extremely narrow joints, the injection of chemicals against rising damp is hardly possible. Therefore, other interventions are needed to reduce as much as possible the rising damp, such as an appropriate draining system around the monument or polyurethane injections in the soil under the monument.
- The complete restoration, and particularly joint repointing, of the monument.

Since no durable conservation plan can be formulated, this monument is lost together with its social and document value. The only possibility of restoring the monument is, apart from the interventions to prevent the uptake of moisture, to replace the damaged parts by copies in a more durable stone (such as the Massangis Roche Jaune).
