Protection of Existing Highway Bridges by Means of Water Repellent Treatment – A Pilot Project

T. Gebhart

Sto AG, Germany

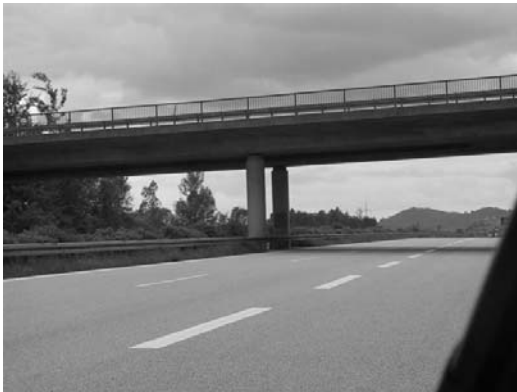
Figure 1: Bridge over the motorway

Some of the most heavily affected areas are the central supports of bridges built over motorways. These stand unprotected in the splash zone of de-icing salts and are therefore exposed to high chloride burdens during the winter months leading in time to heavy corrosion damage in the concrete. When this occurs, technologically, economically and ecologically costly renovations are necessary. This will be made clear through a practical example.

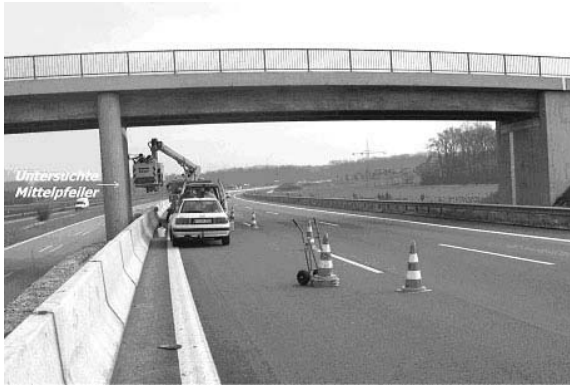
Figure 2: Points of drill core sampling

During the preliminary investigations, carried out by the University of Applied Sciences, Karlsruhe, in co-operation with the Karlsruhe Research Centre [1], the condition of 17 bridges of varying ages in the Bavarian motorway network was recorded. For this, drill cores were obtained for later investigation in the laboratory. The bridge pillars standing in the splash zone were inspected. From each pillar, two sets of cores were drilled for each of the selected heights: approximately 0.30 m (cores 1-1 and 1-2); 1.30 m (cores 2-1 and 2-2); and, 2.30 m (cores 3-1 and 3-2). The diameter of the cores is 70 mm, their length varies between 50 and 70 mm.

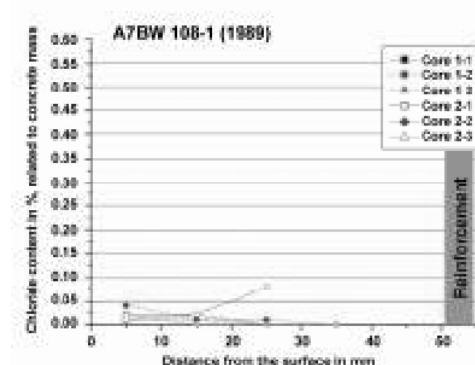
The chloride profiles are shown in Figures 6 and 7 where the position of the reinforcement is also illustrated. The data presented are the average of two drill cores per height for the indicated bridge.

Figure 6: Chloride profile bridge 4 (1989)

As the reinforcement cover for all bridges is relatively thick, approx. 6 cm, the risk of reinforcement corrosion from chlorides can be estimated as relatively low for the majority of structures (bridge 4, Fig. 6). In individual cases, however, the chloride penetration depth already reaches the level of the reinforcement, as for example in bridge 1 for the core drilled at 0.30 m (see Fig.7).

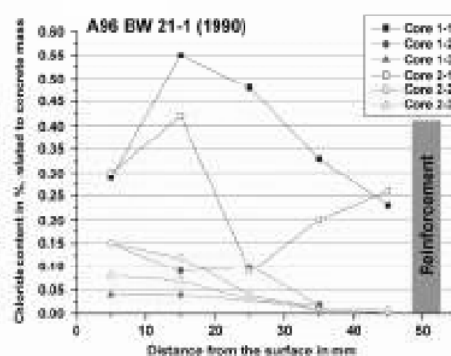
Figure 7: Chloride profile bridge 1 (1990)
