# WITTENBERG'S CASTLE CHURCH TOWER CLASSIC EXAMPLE FOR SUCCESSFUL MONUMENT RESTORATION

Dr Rudolf Hager  
Wacker-Chemie GmbH  
Germany

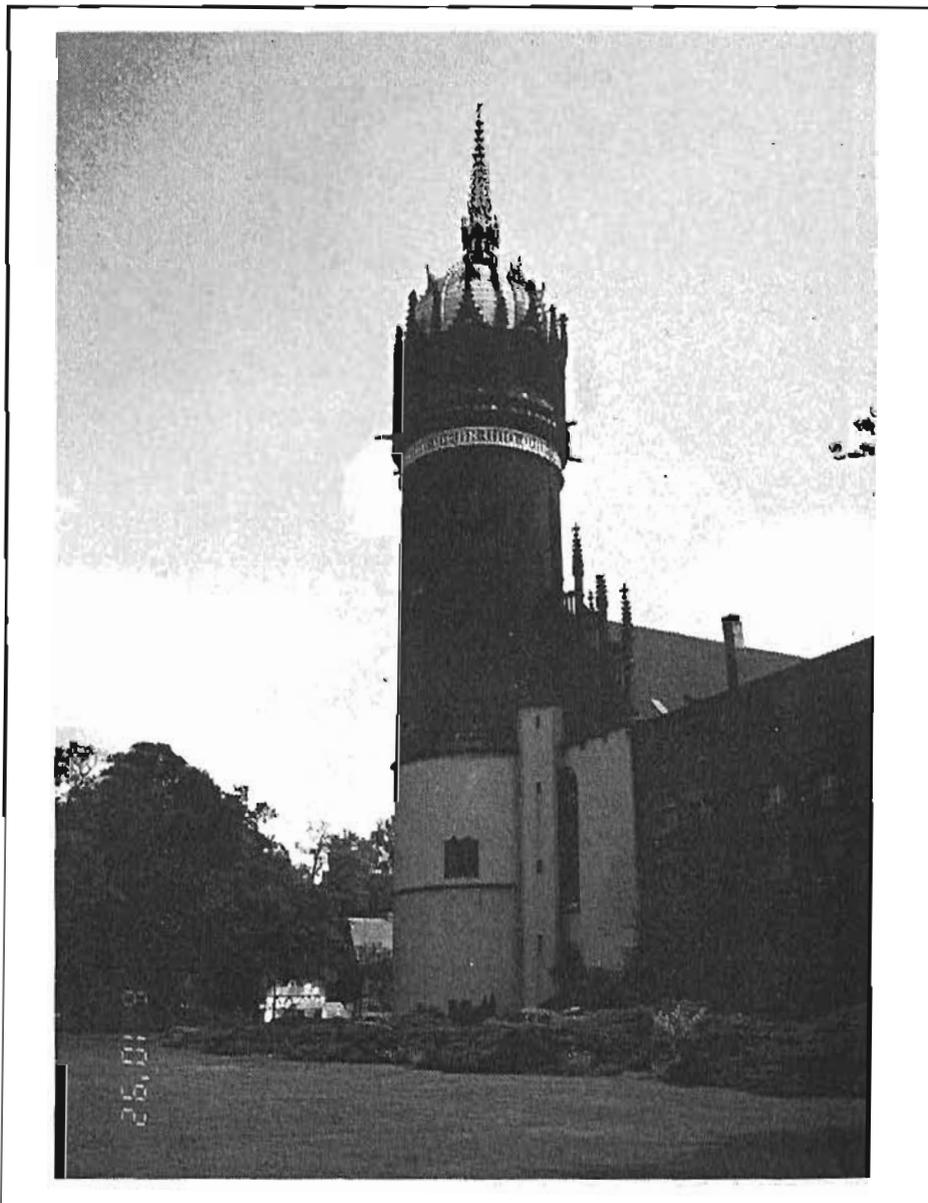
Before work can be started on the restoration of a monument, the extent of structural damage must be determined and its causes analysed. The photograph below shows the tower in its original condition:

The lower section of the tower consists of plastered masonry. The plaster, which contains cement, was renewed only a few years ago. The upper section consists of sandstone squares and sandstone ornaments. The surfaces are badly soiled and in the rain-protected areas in particular there are thick, black crusts of dirt as shown by the next photograph.
