# EXPERIENCES WITH IMPREGNATED CONCRETE SURFACES: PARCO MARAINI IN LUGANO

Cristoforo Bissig,  
Wolfseher und Partner AG, Zurich

The structure above Parco Maraini in Lugano was constructed in 1986 and extends to four independent building complexes. The outer shell of the buildings was executed as a bracket-mounted façade.

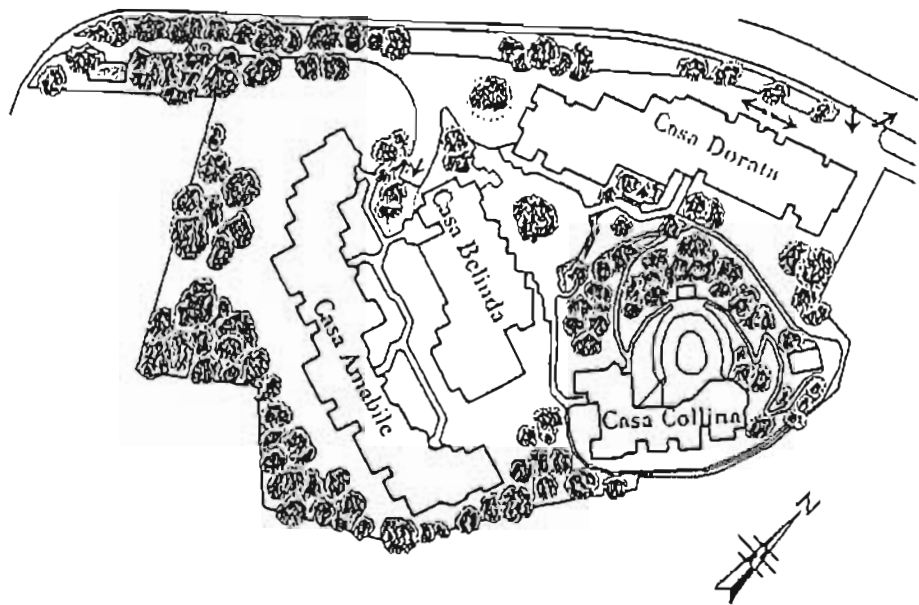
FIG. 1 General view of the structure over Parco Maraini

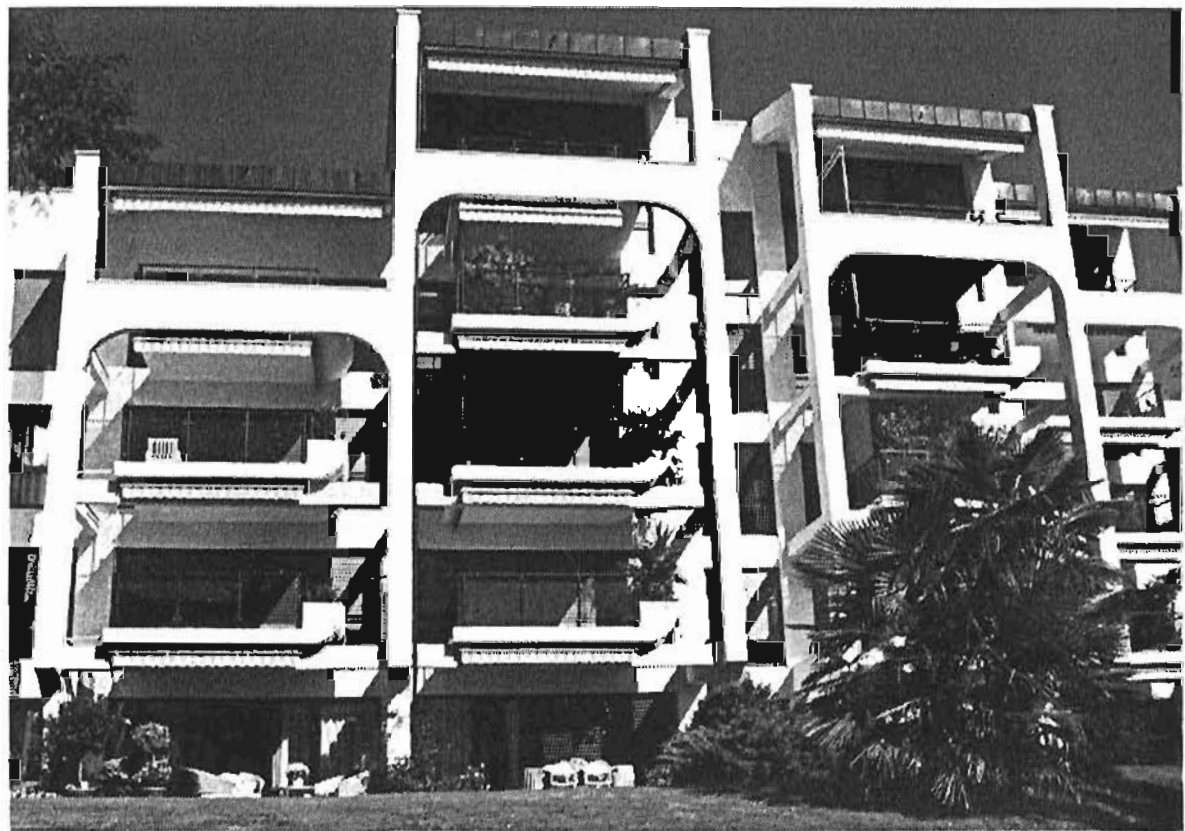
FIG. 2 Projection of south façade

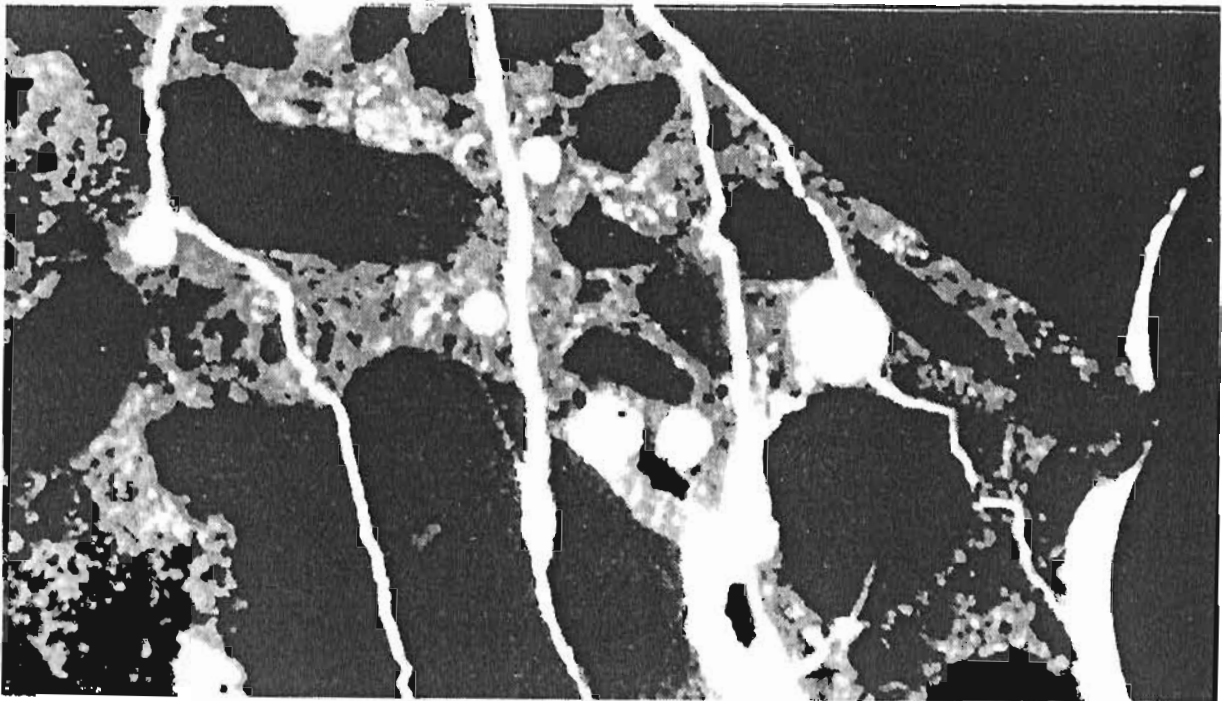
As a result of the surface treatment used (stacking), cracks with a depth of up to 20 mm occur in the structure. The resulting cracks facilitate penetration by water and harmful substances. This leads to a reduction in the frost resistance, and in a locally increased depth of carbonization along the flanks of the cracks.

Fig. 3 Thin section through a concrete sample after mechanical pre-treatment (stacking)

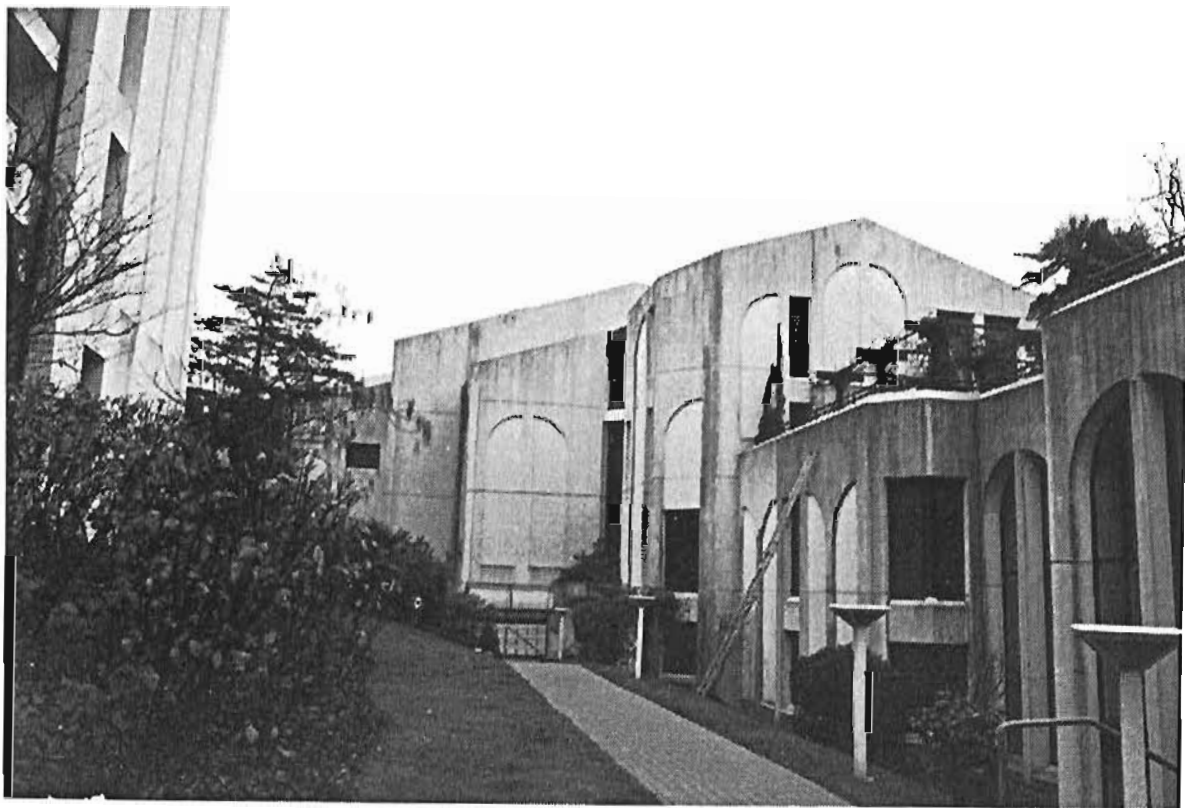
As a result of the surface unevenness of up to 2 cm caused by stacking, heavy soiling had already occurred in some cases on the exposed concrete surfaces only three years after completion of the building. Cracking and flaking of the concrete surface had occurred at some points on the weathered

- Exposed, corroding reinforcement.
- Occasional flaking and cracking above corroding reinforcement close to the surface.
- Defective and embrittled compound-filled joints.
- Twisting and tilting of individual bracket-mounted elements.
- Heavy contamination of façades due to missing roof edge covers.

FIG. 4 Projection of north façade before sanitation.

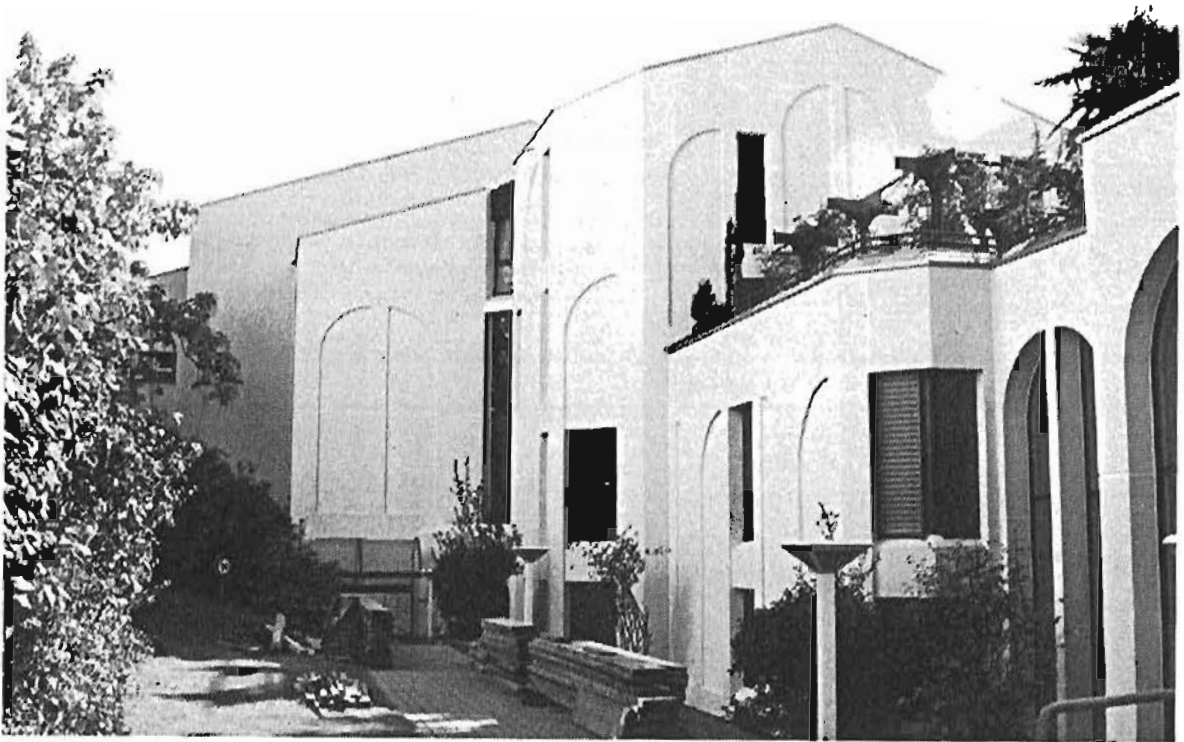
FIG. 5 Projection of north façade after sanitation.

A start was made on the commissioned work for "Casa Amabile" in March 1995. The work was completed after 8 months, at the end of October 1995. Around 8'000 m<sup>2</sup> of concrete surface in total were protected with a water-repellent coating. The water-repellent coating was applied unpressurized with a Birchmeier spray pump in three stages. The coats were applied wet-on-wet.
