## C-1-4 Impregnation treatment with hydrophobic silane to an important stone building suffering from freezing damage in cold and heavy snowfall district

*ABSTRACT: An important historic stone building (1906) in a cold and heavy snowfall district, Otaru, Hokkaido, Japan, had been suffering from freezing damage because of frequent freeze-thaw cycles in early spring. In order to revive the cohesion of the damaged stones (porous tuff) and protect them from water penetration, impregnation treatment with hydrophobic silicone resin (a solution of the oligomer of methyl triethoxy silane in organic solvent) was executed. Several years later, a serious trouble occurred. The layers of some stones, into which the resin had penetrated, had become detached. Detailed investigation revealed that the cause and the mechanism of this trouble is as follows: Because the waterproofing of the roof was insufficient, snow water penetrated into the stones from the untreated side and the water froze to make ice crystals in the interface between resin-treated layer and untreated layer; the growth of the ice crystals led to the breaking of the stones. Thus, covering the roof with copper sheet was carried out

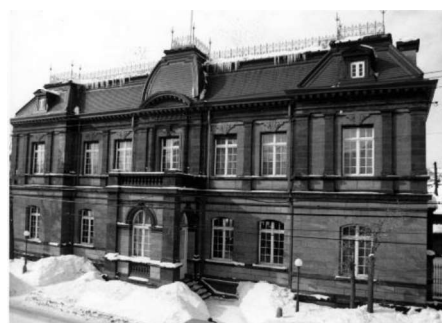
Fig. 2. An important historic stone building

The stone building discussed in the present paper was constructed in 1906 and is located in Otaru, Hokkaido, which is a cold and heavy snowfall district in Japan. This modern European-type building, which had been used as the office of a famous shipping line company, is beautiful and unique to Japanese history of architecture. It was designated an important cultural property of Japan in 1969. The stones of the building are porous tuff for the main parts and porous andesite for the decorative parts. Those stones had suffered from freezing damage to a great

extent. Thus, conservation work was carried out on the building from 1984 to 1987; now, it is open to the public as an important historic heritage.

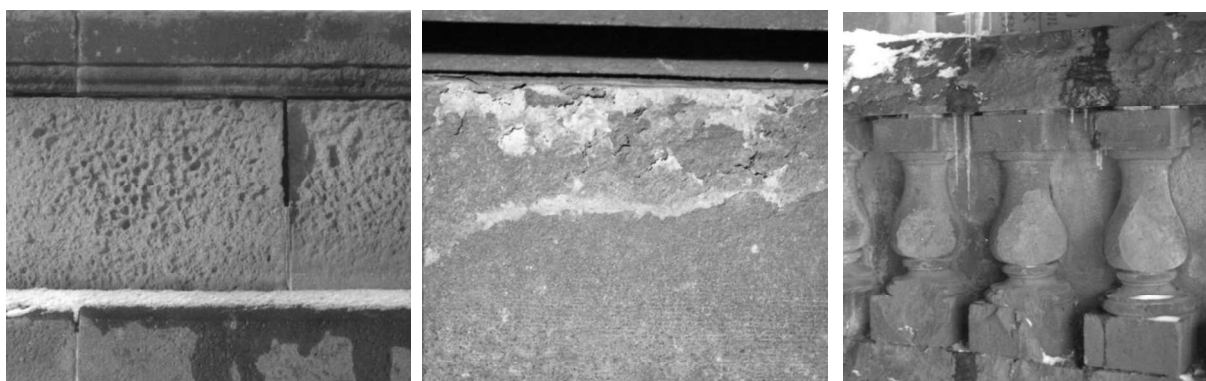
Stone	Porosity (%)	Colour	Places used	Deterioration
Tuff	45-48	Grayish light brown	Walls and columns	Granulation and powdering of the surface layer
Andesite	23-26	Dark grey	Decoration of the facade	Breaking

Fig.3. Freezing damages to the stones

Deterioration of the tuff is often caused by the crystallization of salts. In this case, however, considering the total condition of the stones, it was determined that deterioration was caused by freeze-thaw cycles of the water in the stones.

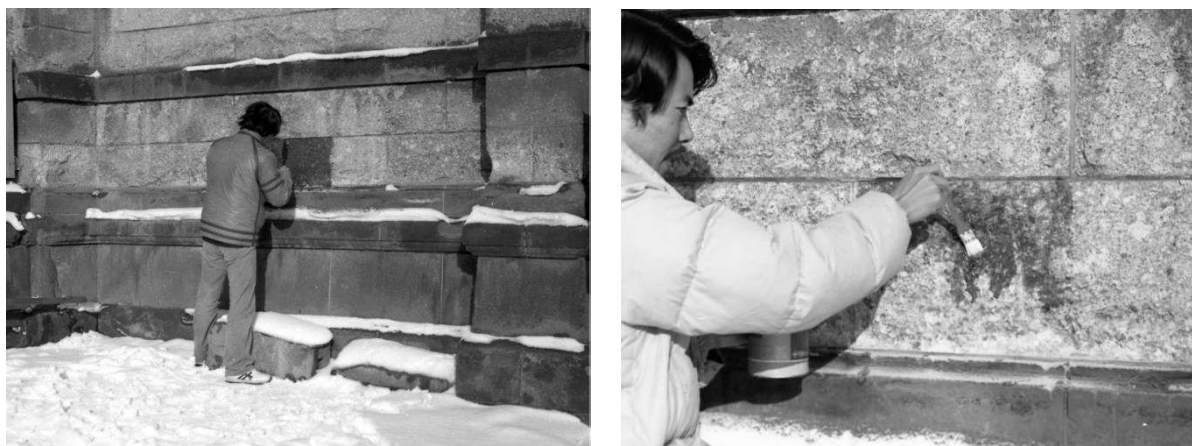
Fig.6. Conservation work

Considerations and experimental tests to ensure deep penetration of the solution by brushing into the stones which are the parts of the building were conducted by the Tokyo National Research Institute for Cultural Properties. Then the practical treatments at the sight were executed as follows:

- (1) The stones were dried as much as possible by using a jet heater.
- (2) Silicone solution was applied by brushing as much as possible (actually more than  $3\text{kg/m}^2$ ). In this case, application of the solution was not repeated but accomplished in one time so that deeper penetration was gotten, which is a very important point of this treatment.
