Hydrophobicity – One Target, Several Possibilities

G. Hilbert¹, H.-H. Neumann² and E. Wendler³

Abstract

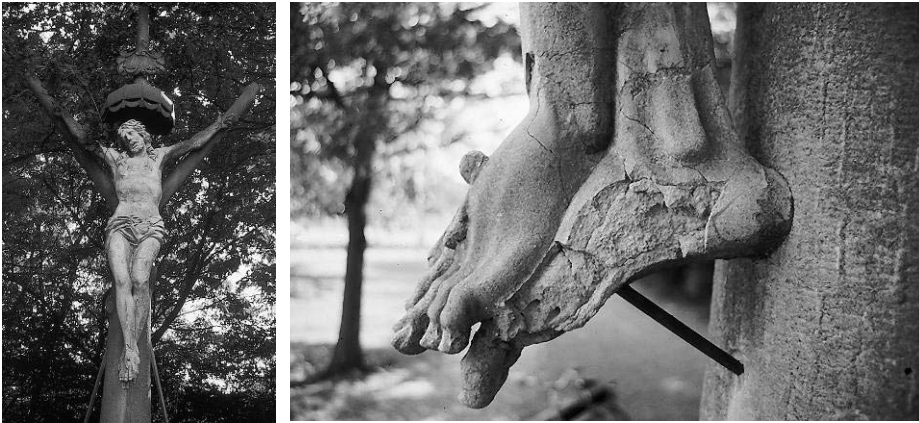
Figure 1: Left: A crucifix made of Baumberg sandstone (Münster, Germany). Right: Spalling caused by the impregnation agent that was applied (detail in the illustration on the right)

"Water is the source of all problems." This opinion was widely held, especially during the 70s and 80s of the last century, in research on the causes of damage through weathering in the field of monument preservation. The result of these often simplistic statements was that the substrate of many objects was treated with a hydrophobizing impregnation agent as the final "crowning" restoration measure. The consequence: Over the course of time, damage was observed on some but not all of the objects treated in this manner (see Figure 1).

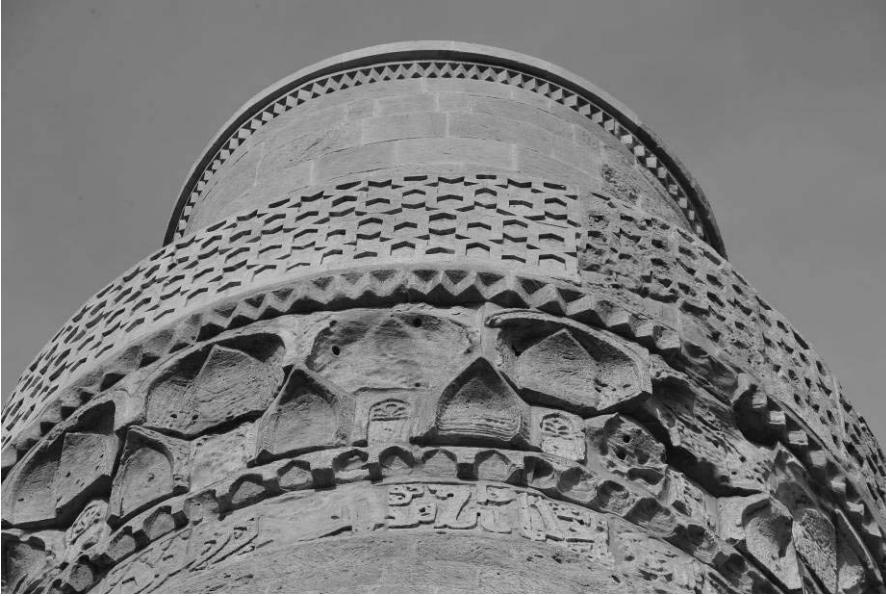
Figure 4: A balustrade area of the Mohammed Mosque which had been strengthened in a very complicated, negative pressure procedure

Bottom line: In the case of the Mohammed Mosque shown in the restored state in Figure 4, there were a number of reasons that spoke against water repelling treatment of the substrate in general and in particular against the application of a hydrophobizing impregnation agent.

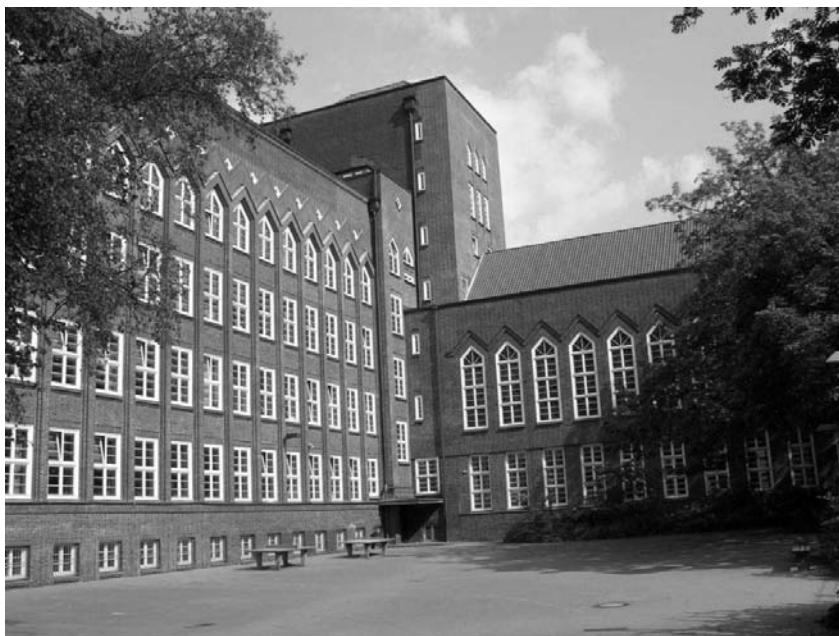
Figure 6: Typical architecture of buildings made of peat moss fired clinker in the Hamburg area. The practically non-absorbent, very hard clinker is typical

The historically protected facade shown in Figure 6 is made of a hard, not very absorbent clinker brick. At the time an inquiry was received concerning a hydrophobizing impregnation, the facade had just been restored by replacing the pointing.

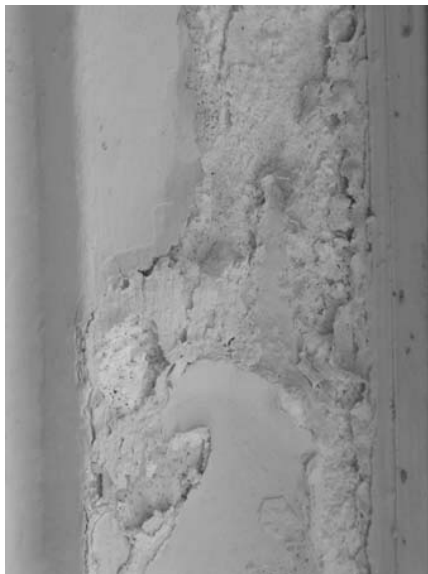
Figure 7: Damage caused by moisture in an interior area of the school building shown in III. 6 – the extent of the damage indicates the magnitude of the quantity of moisture penetrating into the building

The results the examinations and the following report given to the owner of the building was surprising to many of those involved – an impregnation agent was not the solution for the problem shown in Figure 7.

Further examinations showed that the damage was caused by faulty execution of the new pointing that had recently been carried out. Viewed under a microscope, lateral detachment was observed in many places, taking the form of sheet-like capillaries between the clinker and joint mortar. Their dimensions were so large – similar to the Azerbaijan limestone – that a hydrophobizing impregnation could not remedy the problem. Similar to the case in Baku, the execution of hydrophobizing measures on the object in Hamburg would only cause damage in the future.

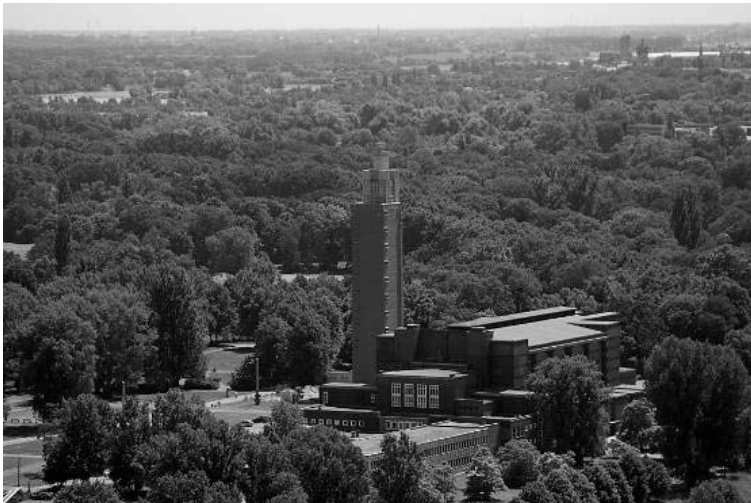
Figure 8: Aerial view of the viewing tower in Rotehornpark / Magdeburg

Built in the years 1926/27 according to plans drafted by Albin Müller for a theatre exhibition, the building material technology on which the structure is based is unique. One of the first concrete frame structures built in Germany, the structure is infilled with "Ambiwinkel" concrete blocks.

With historical concrete, the situation is often different. In the field of preserving concrete, extremely open-pored structures are found since the structure or water-cement value was often not optimised. An example of this is the viewing tower in Rotehornpark / Magdeburg (see Figure 8).

- The "Ambiwinkel" concrete blocks as well as their filling are extremely coarse pored and their structure cannot be compared to "normal" concrete.
- In spite of large pores, the building material is highly absorbent overall which led to the penetration of moisture into the interior of the viewing tower, particularly on the weather side.
- The unit of the building material shown here is completely carbonated – the embedded steel no longer has any protection against corrosion through a high pH value.

Bottom line: The viewing tower in Magdeburg is one example of a monument that could not be preserved without hydrophobizing treatment. Even with the most critical discussion, no other approach will lead to a concept for a permanent solution. The combined use of an impregnation agent and a water repelling grout makes sense for the conditions of this particular object. But the measure will only be effective over the long-term if regular maintenance is carried out – in this case by continuously closing the cracks that form in the west facade caused by the construction.

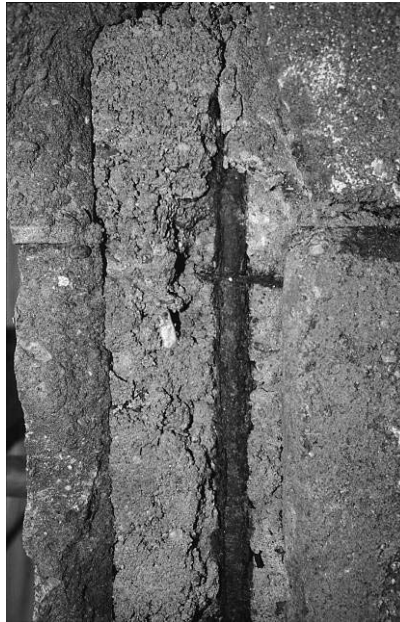
Figure 9: Structural detail of the "Ambiwinkel" block construction

"Ambiwinkel" concrete blocks are hand-formed, L-shaped blocks that were made at the building site, using Portland cement as a binder. They were built into the facade in twos, standing opposite each other so that there is a cavity in the middle of the two stones which was then also filled at the building site with a binder/aggregate mix. Steel reinforcement was laid into the cavity filling to increase the structural stability of the construction. A cut cross-section of this construction is shown in Figure 9.
