Brick-Wall Masonry Decay Patterns and In Situ Evaluation of the Effectiveness of Treatments of Torre Alberaria in Venice

V. Fassina¹, M. Favaro² and D. Melica³

In the framework of the European Project ASSET n. EVK4-2000-00572 "Assessment of suitable products for the conservative treatments of sea-salt decay", the effectiveness of some selected products intended to be used as water repellents and consolidants on the brick-wall masonry located in a costal environment and damaged by salt crystallisation due to different salt-sources was evaluated.

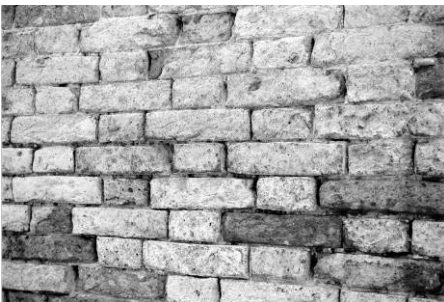
Figure 1: Salt efflorescences on bricks surface

The emission of sea-salt particles from the sea is one of the most relevant sea-salt sources. Marine aerosols can be transported at a long distance from sea into the inland and they are removed from the atmosphere by wet and dry deposition processes. The enrichment of sea-salt by sea spray in historic monuments has been going on continuously over long periods of time. Accumulations found today are the result of sea salt deposition beginning at the time of construction of the building (Figure 1).

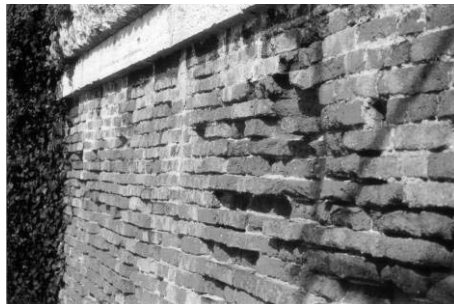
Figure 2: Weathering from marine spray on brick surface

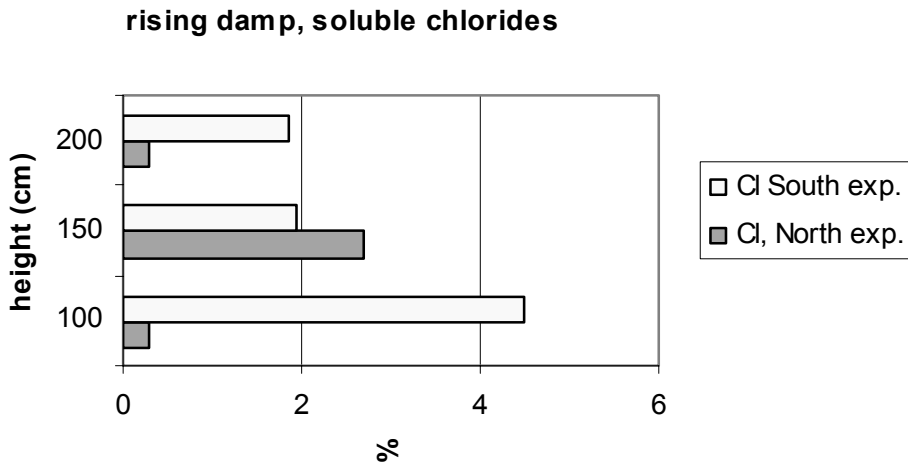
Figure 4: Concentration of chlorides at different heights

In high tide zone, chlorides (mostly sodium chloride, halite) reach the maximum concentration, 4.7 %, at 50 cm. height on both north and south sides, which means that the tide wets both sides of the basement with the same frequency, while sulphates at the same height is more abundant on the north side in respect to the south one (respectively 2.7 and 0.8 %). Such phenomenon is probably due to the slower water evaporation occurring on the north side which maintains the surface more moist thus favouring the process of sulphation on the surface. On the contrary, on the south wall, where unsheltered surface is more exposed to the wind and sunlight, the interaction between the substrate and the atmospheric pollutants is limited. This hypothesis is confirmed also by the XRD semi-quantitative determination of high quantities of gypsum, the only mineralogical phase of sulphates present. In the area interested by rising groundwater, data obtained show that the concentration of soluble salts largely depends on the exposure: in the south wall, chlorides concentration is generally greater in respect to the north one (4.5 and 2.7 % respectively at 100 and 150 cm height). Moreover in the south, the rising groundwater reaches lower height in respect to the north one. Such behaviour is closely related to the more effective process of water evaporation taking place on the south wall that is mainly exposed to sunlight and strong winds (Figure 4). Sulphates, identified as gypsum and

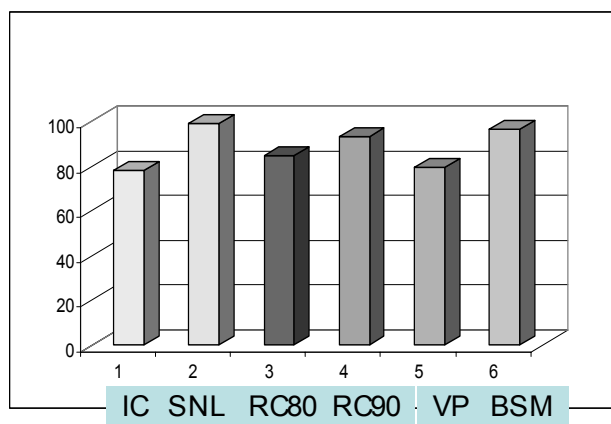
Figure 8: PD_p % after one month from the application

The $PD_p\%$ was calculated after 1 and 6 months from the application of the products. Data obtained comparing the results obtained before and after treatment, allow us to establish that one month after the application the $PD_p\%$ is over 80% for all the tested products (Figure 8), but six months after the application, this parameter is still so high only for Funcosil IC and Dynasytan BSM 40SKI (table 5).
