# CROSS-SECTIONAL WATER-REPELLENT TREATMENT OF REPAIR MORTARS

## EXPERIENCES FROM LONG-TERM BEHAVIOR

Klaus Droll und Hermann G. Meier

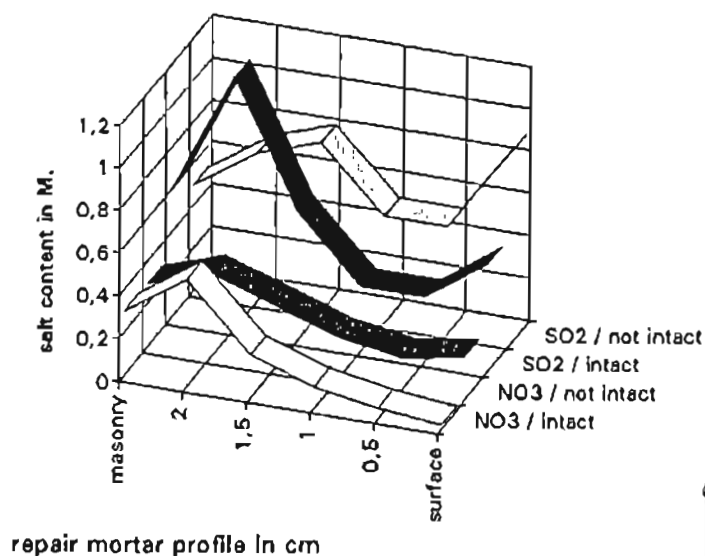
FIG. 4B

Salts are transported by moisture (rising or circulating) in the masonry. It is not, therefore, surprising that the salt profile is parallel to the moisture profile. This is the salt profile for the repair mortar (approx. 2 cm thick).

Salt concentration profile in repair mortars
