Hydrophobe III -

3rd International Conference on Surface Technology with Water Repellent Agents, Aedificatio Publishers, 203–218 (2001)

Experiments on the Compatibility of a Polysiloxane Treatment with Substrates Loaded with Sodium Sulphate: Influence of the Physical Properties of Substrates on the Salt Content Limit

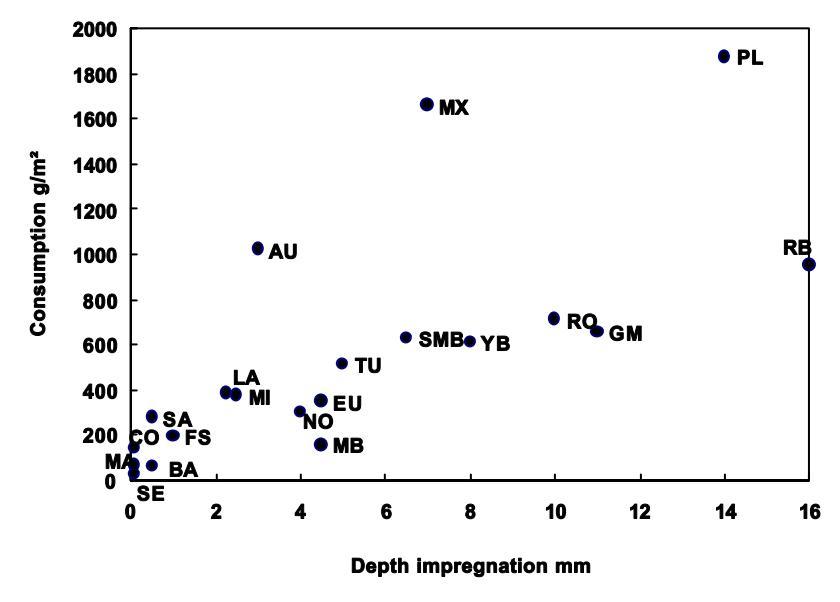
Figure 1: C_{H224} in relationship to D_{H224}

The average water repellent consumption C_{H224} (g/m²) was evaluated by weighing. The samples were broken at right angles to the treated surface and the crosssection was put into contact with water for a few seconds. Then, it was possible to roughly determine depth impregnation D_{H224} (mm) by measuring the observed thickness of the dry layer. Impregnation depth increases with consumption (Fig 1). However, materials could be differentiated into 2 groups. The first one composed by AU, MX and PL , while the second group includes all the other materials.

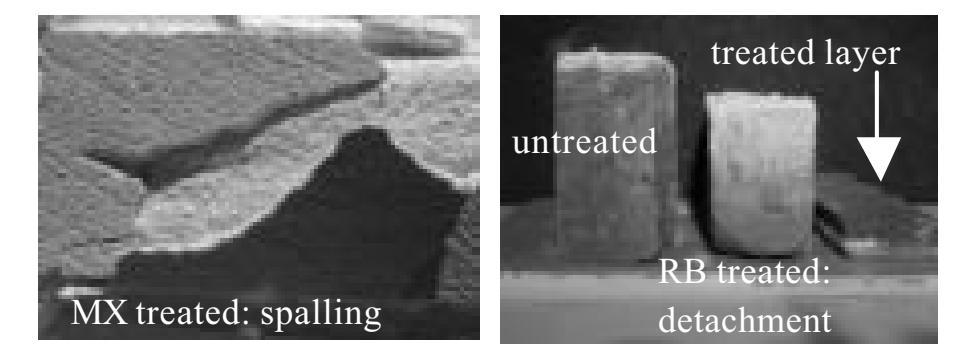
Figure 2: Crystallization : observation

tion. On treated samples, spalling was more frequent (Fig 2). Different types of damage were observed depending on limestone granulometry. For example, the damage on untreated MI appeared as thin successive flakes perpendicular to the bedding, but as crumbling in the case of untreated SA. So far, the 2 limestones (EU and BA) with lowest CMC have not shown any damage within the initial salt content range examined. Bricks (except RO, and all of the untreated samples without surface disintegration but with salt efflorescence) were damaged with different ini-

tial salt contents. On untreated bricks, the damage appeared as crumbling. On the treated samples, as detachment of part of the surface and as crypto-efflorescence just below the treated part. Concerning sandstones (except the lowest-capillarity SE), they were all damaged, GM in particular. Untreated sandstones showed scaling and sometimes splitting. For treated sandstones, bulging was first noticeable followed by spalling. TU was visually more damaged than AU. Plaster, the material with highest CMC, behaved differently from all other materials: it showed the highest impregnation depth as well as the highest initial salt content for deterioration. For untreated PL samples, all the salt migrated with the liquid flow to the top and crystallised outside the solid matrix whilst treated samples only showed powdering as if the treatment had protected it.

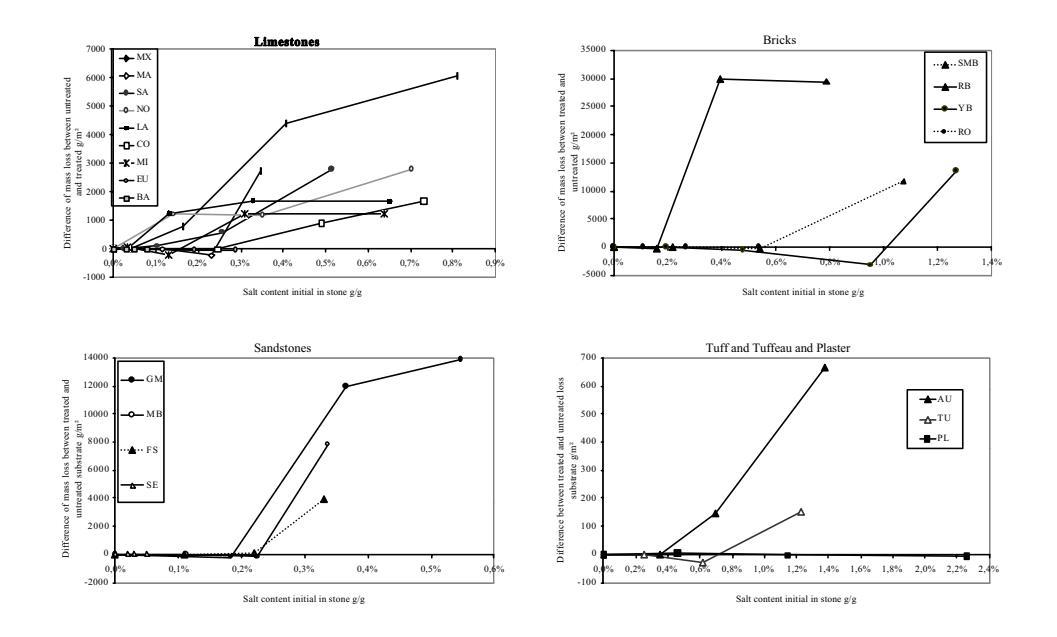
Figure 3: Treated and untreated substrates: mass loss difference as a function of initial salt content

The difference of substrate loss between untreated and treated samples ($M_{sub,H224} - M_{sub}$) as a function of the initial salt content was plotted (Fig 3) to elucidate the influence of the degree of salting on the damage for each material.

For limestones and for the same amount of salt, the difference of mass loss of MX due to the treatment(6000 g/m^2) is higher than for other limestones according to visual examination. Its alteration depth corresponds to the impregnation depth of H224. The LA and NO stones both show similar differences in mass loss and they behave in the same way. For bricks except for RO, the mass loss at different salt contents reaches a higher constant value (15000-30000 g/m²). This increase in degree of deterioration is proportional to the impregnation depth as in the case of

limestones. The YB mass loss is lower than for RB whilst the admissible salt limit for these 2 bricks is really different (it is more important for YB which shows a lower capillarity coefficient and higher mechanical resistance than RB). Furthermore, the drying time to reach hygroscopic equilibrium is higher for YB (7 months) than for RB (2 months). AU shows a higher difference in mass loss than TU contrarily to what can be visually observed. PL does not show any significant difference and its mass loss remains very low (30-40g/m²) in comparison to other substrates.

In each category, all of the treated samples lost more mass than the untreated samples and the mass loss increased with increased initial salt content.

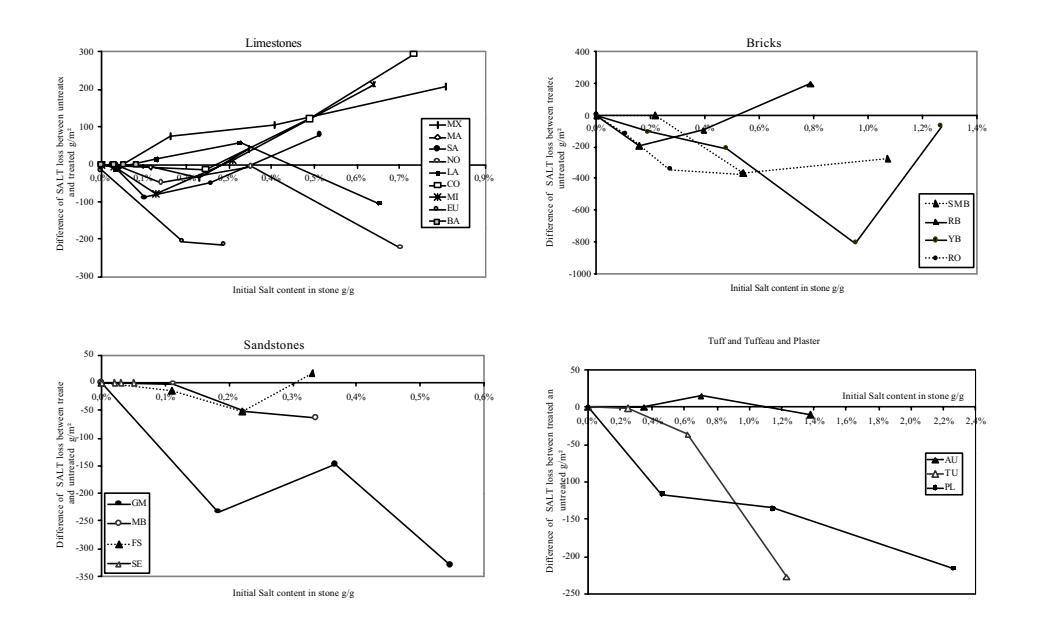
Figure 4: Treated and untreated substrates: collected salt difference as a function of initial salt content

As previously, the difference of salt loss between untreated and treated samples $(M_{salt,H224} - M_{salt})$ as a function of the initial salt content was plotted (Fig 4) to study the influence of the initial salting degree on salt crystallization.

As can be seen this difference is negative for most substrates: less salt was collected from treated than from untreated samples.

For untreated plaster samples, whatever the initial salt content was, 94% of the initial salt content was collected whereas few salt was collected from treated samples. However, for some substrates (MX, CO, MI, SA, FS, RB), more salt was collected on treated samples than on untreated samples.

The results are in accordance with the difference in mass loss: the percentage of substrate loss increases with the percentage of collected salt.

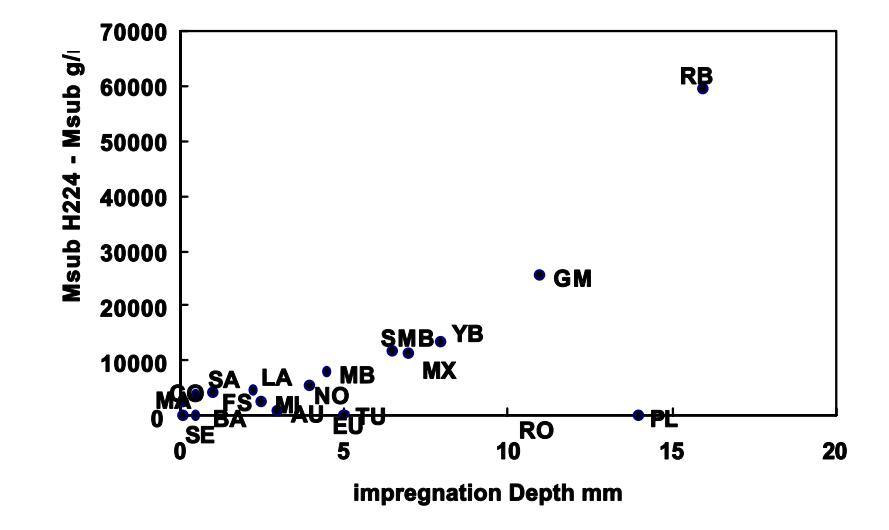
Figure 5: Mass loss difference (M_{subH224} - M_{sub}) as a function of depth impregnation

From the results obtained from both treated and untreated samples (Fig 5), it is clearly evident that the impregnation depth accounts to a large extent for the difference in mass loss ($M_{sub H224} - M_{sub}$).

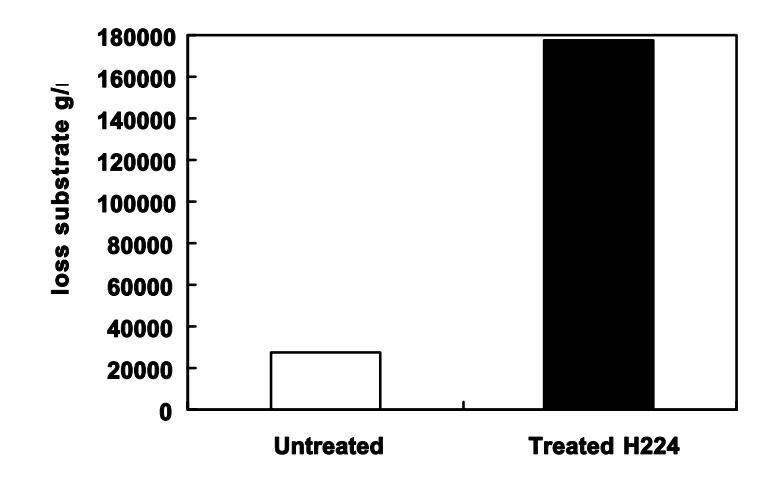
Figure 6: Untreated and treated: mass loss

In most cases, from the quali- and the quantitative evaluations (Fig 6), the type of damage is more serious and significant on treated samples than on untreated samples whilst the collected salt is less important in the case of treated samples (Fig 7).

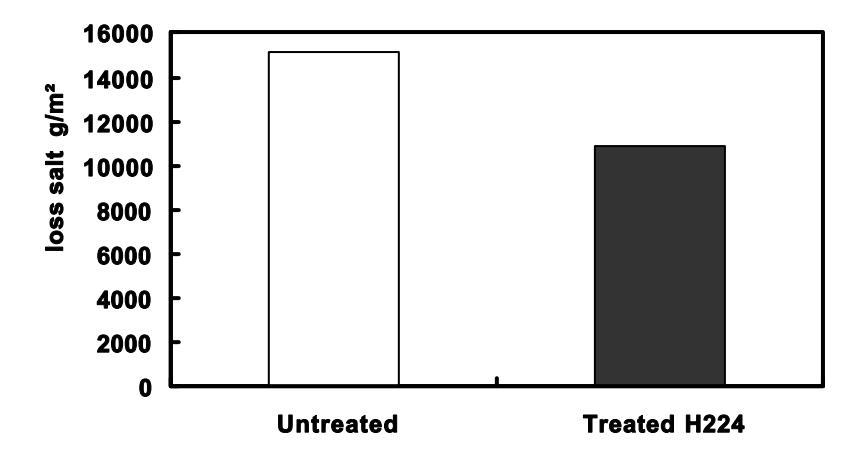
Figure 7: Untreated and treated: collected salt
