4th International Conference on Water Repellent Treatment of Building Materials Aedificatio Publishers, 171–184 (2005)

Performance of Single Materials Treated with a Water Repellent and Contaminated with a Salt Mix

H. De Clercq

Royal Institute for Cultural Heritage (KIK-IRPA), Brussels, Belgium

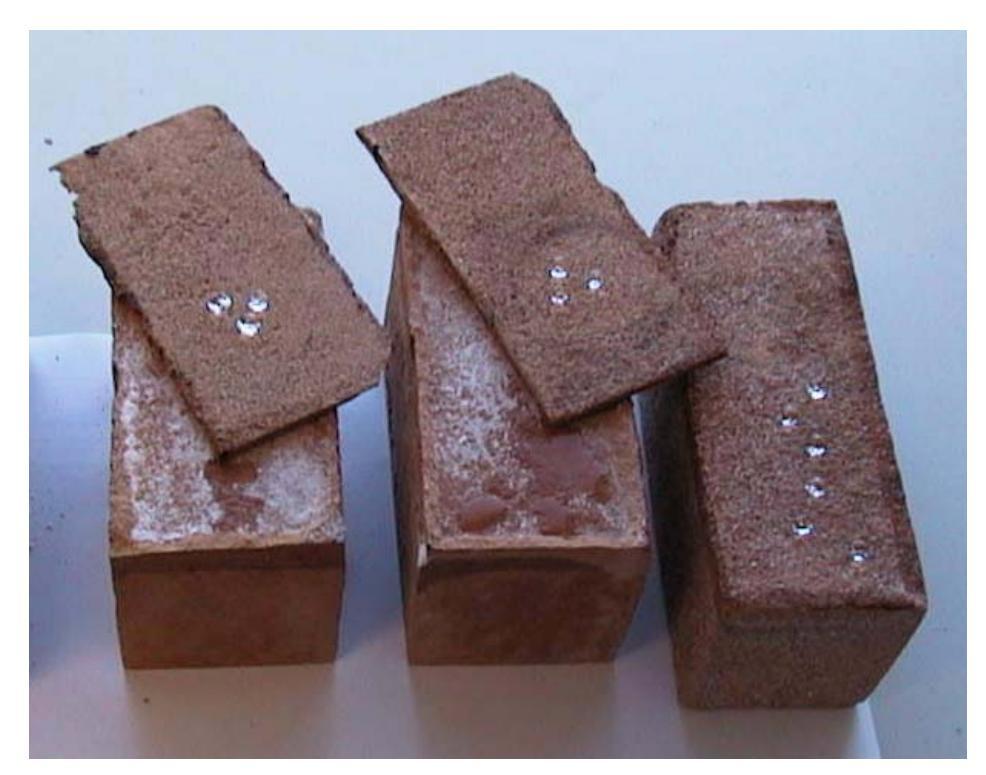
Figure 1: Damage on the Italian brick contaminated with a Na₂SO₄ –NaCl-KNO₃ mixture of, from left to right, 4-1-1, 4-2-1 and 4-1-2. A value of 1, 2 and 4 corresponds to respectively 0.25, 0.50 and 1.00 w-% of the dry sample

Damage on untreated samples can be described as powdering and crumbling, while on treated samples it varies from powdering and crumbling to scaling and spalling. Its occurrence is generally linked with the deposition of Na₂SO₄ which causes spalling of the water repellent layer of treated samples as illustrated in Figure 1 for some samples of the Italian brick of part III. For the untreated Massangis limestone, the ionic composition of the efflorescence, determined by IC or AAS, has been compared with that of the introduced salt mix. Some results, expressed as ratio of ion content in the salt efflorescence to that in the introduced salt mixture, are presented from Figure 2 to 4.

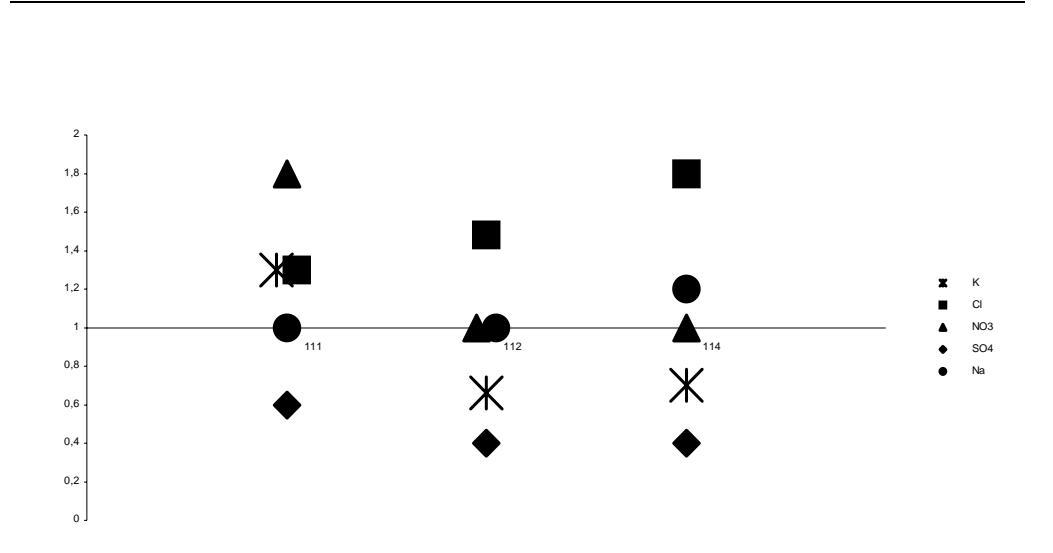
Figure 2: Ratio of ion content in the salt efflorescence to that in the introduced salt mixture after the second crystallisation cycle for the untreated Massangis limestone contaminated with a Na₂SO₄ - NaCl - KNO₃ mixture corresponding to 1-1-1, 1-1-2 and 1-1-4. A value of 1, 2 and 4 corresponds to respectively 0.12, 0.25 and 0.50 w-% of the dry material.

Figure 2 presents the results obtained after the second crystallisation cycle for a contamination of which the NaCl content equals that of Na₂SO₄ (0.12 w-%) while the amount of KNO₃ increases gradually from 0.12 to 0.50 w-%. This figure shows that the efflorescence of chlorides is favoured regardless the KNO₃ content. The content of deposited nitrates is experimentally higher than that of K⁺ which is explained by the formation of darapskite. The efflorescing sulphate content is in all cases lower than theoretically expected. A declining profile is obtained for NO₃⁻, K⁺ and SO₄²⁻.This indicates that increasing the amount of KNO₃ in the mix is not causing an equivalent increase of its content in the efflorescence as well as that of darapskite.

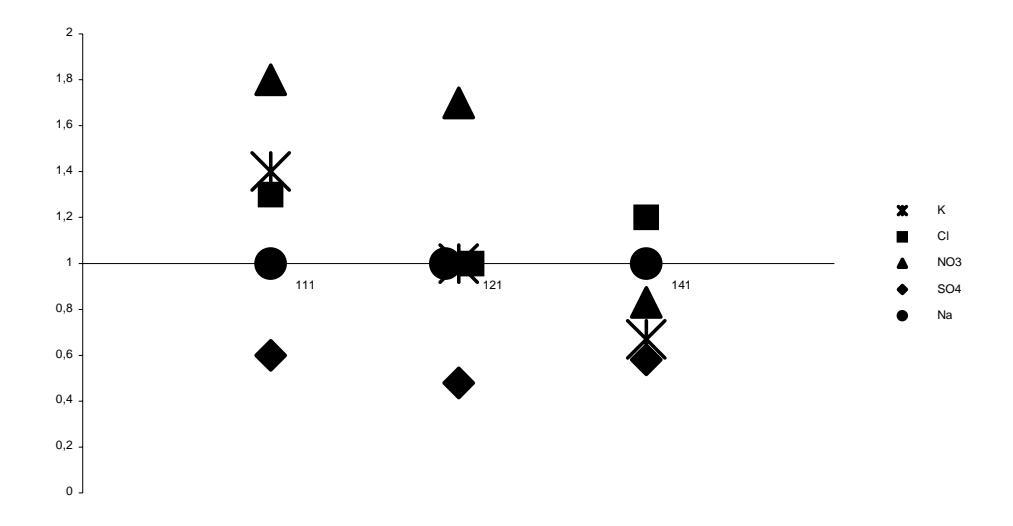
Figure 3: Ratio of ion content in the salt efflorescence to that in the introduced salt mixture after the second crystallisation cycle for the untreated Massangis limestone contaminated with a Na₂SO₄ - NaCl - KNO₃ mixture corresponding to 1-1-1, 1-2-1 and 1-4-1. A value of 1, 2 and 4 corresponds to respectively 0.12, 0.25 and 0.50 w-% of the dry material

Figure 3 presents the results obtained after the second crystallisation cycle for a contamination of which the KNO_3 content equals that of Na_2SO_4 (0.12 w-%) while the amount of NaCl increases gradually from 0.12 to 0.50 w-%. The content of chlorides in the efflorescence approaches that in the introduced salt mix. The efflorescing sulphate content is, similar as described above, lower than theoretically expected. The profiles of K⁺ and

NO_3^- decline indicative for a suppression of the efflorescence of KNO₃ as the amount of NaCl increases.

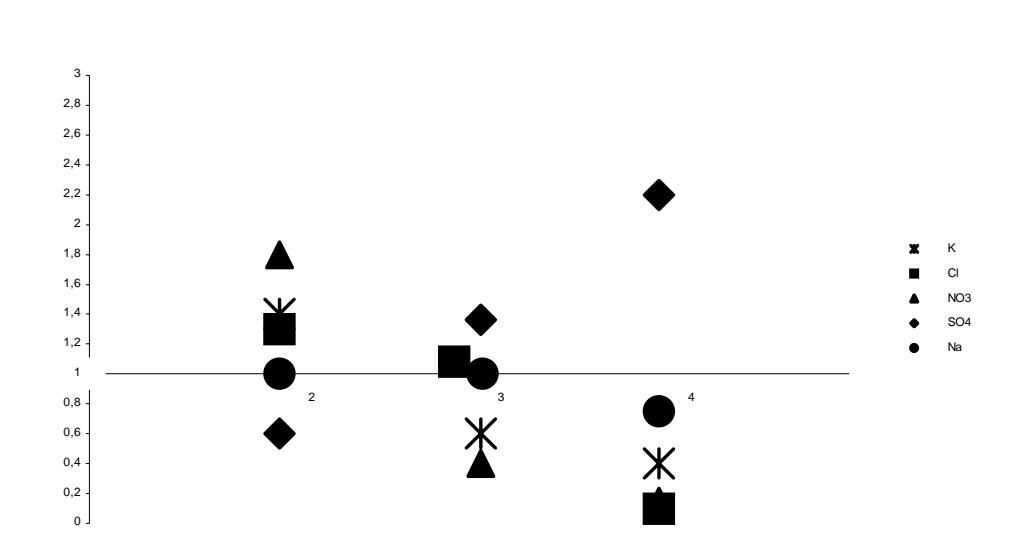
Figure 4: Influence of the salt crystallisation cycle number (2, 3 or 4) on the ratio of ion content in the salt efflorescence to that in the introduced salt mixture for the untreated Massangis limestone containing 0.12 w-% of Na₂SO₄, NaCl and KNO₃ (1-1-1)

After cycle four, an opposite tendency is obtained, in such a way that the efflorescence of chlorides and nitrates is much lower than theoretically expected from the composition of the mix while that of sulphates is favoured. The influence of the salt crystallisation cycle number on the types of ions deposited on the drying surface of the Massangis limestone containing equal amounts of Na₂SO₄, NaCl and KNO₃ is illustrated in Figure 4 which confirms that the efflorescence of nitrates and chlorides decreases with increasing crystallisation cycle number while that of sulphates increases.
